# ATLAS Phase II Upgrade for High Luminosity Stave Core Production at Yale

Paul Tipton (PI)<sup>1</sup>, Jeffery Ashenfelter<sup>1</sup>, Thomas Barker<sup>1</sup>, William Emmet<sup>1</sup>, Thomas Hurteau<sup>1</sup>, Francisco Lopez<sup>1</sup>, Craig Miller<sup>1</sup>, David Lynn<sup>2</sup>, Soeren Prell<sup>3</sup>

<sup>1</sup>Yale University, <sup>2</sup>Brookhaven National Laboratory, <sup>3</sup>Iowa State University

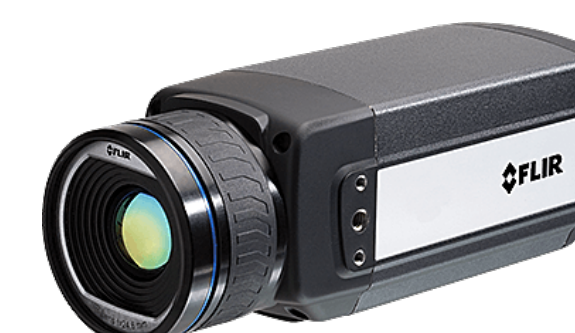
- FLIR A655sc thermal camera chosen as optimal match to QA

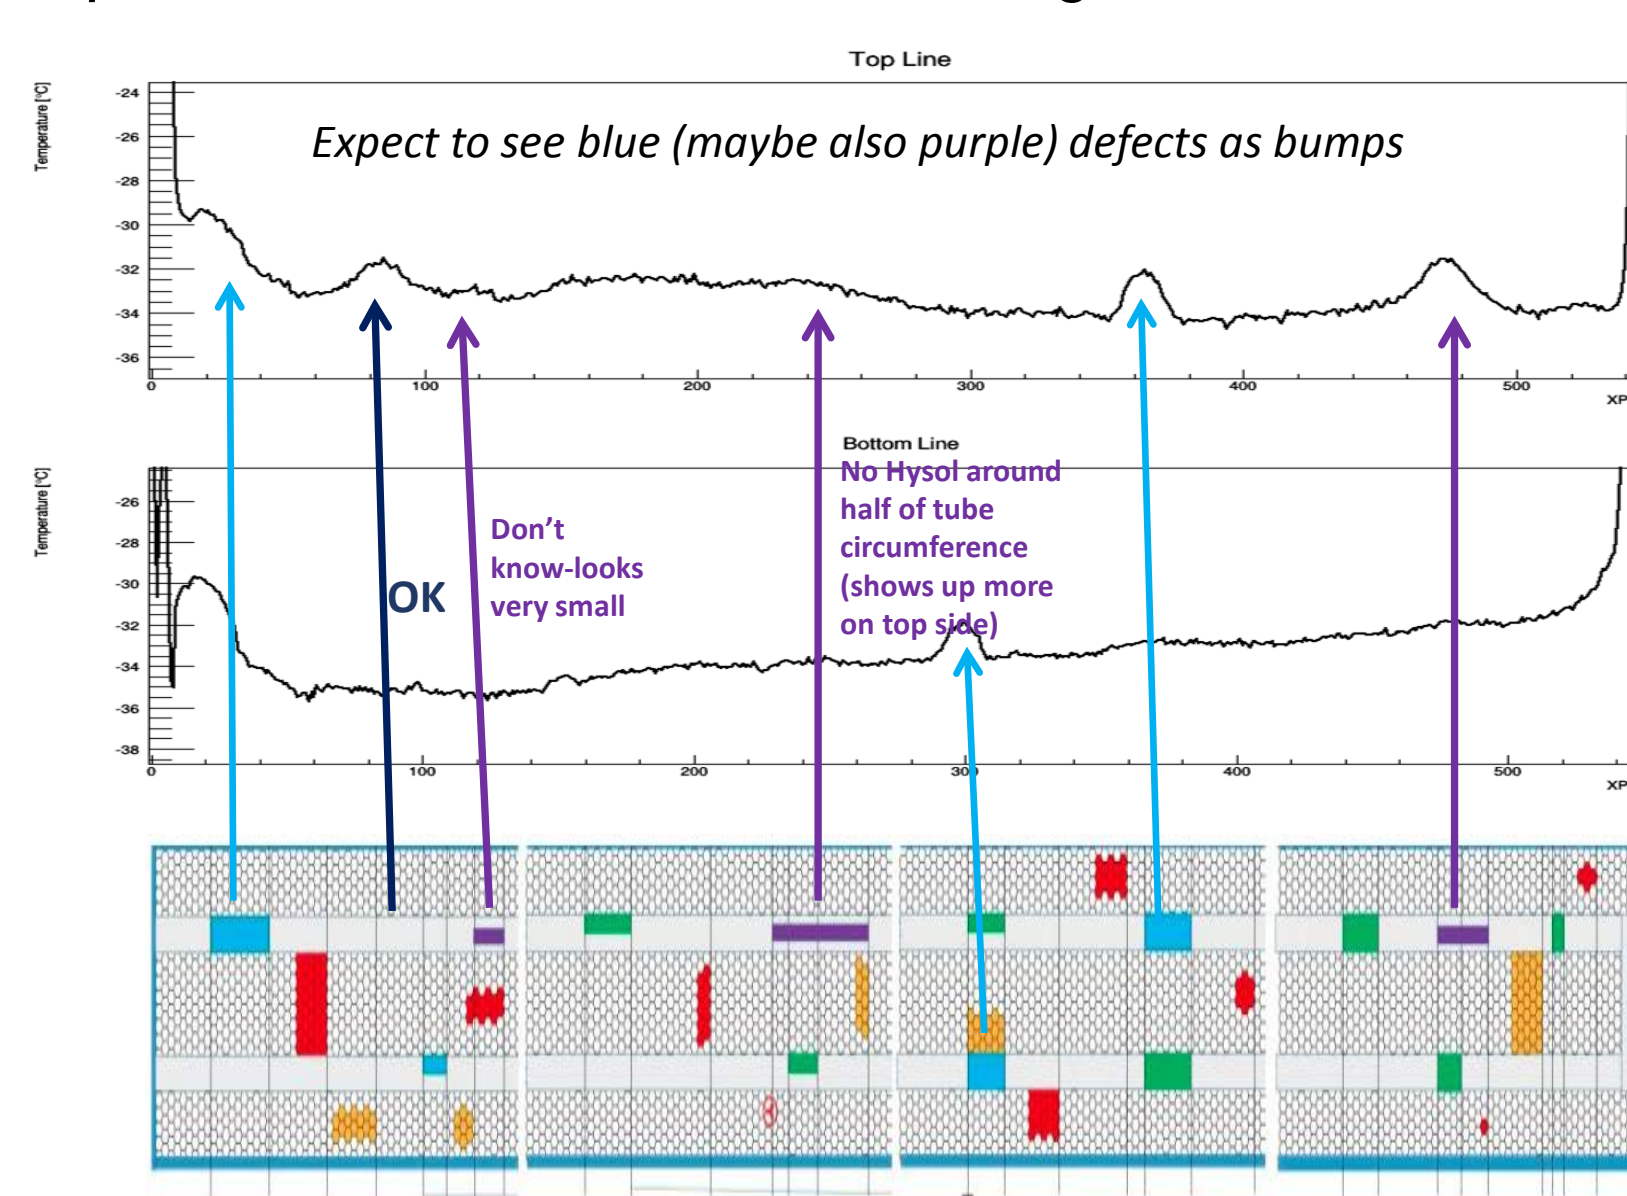
Delaminations are identified as bumps and dips in the temperature profile; for now we look at small regions over centers of cooling pipes
